FM Blanketing Interference: A Case Study of Problems and Solutions for a Typical High Power FM Station

Thomas M. Eckels, P.E. Hatfield & Dawson Consulting Engineers, Inc. Seattle, Washington

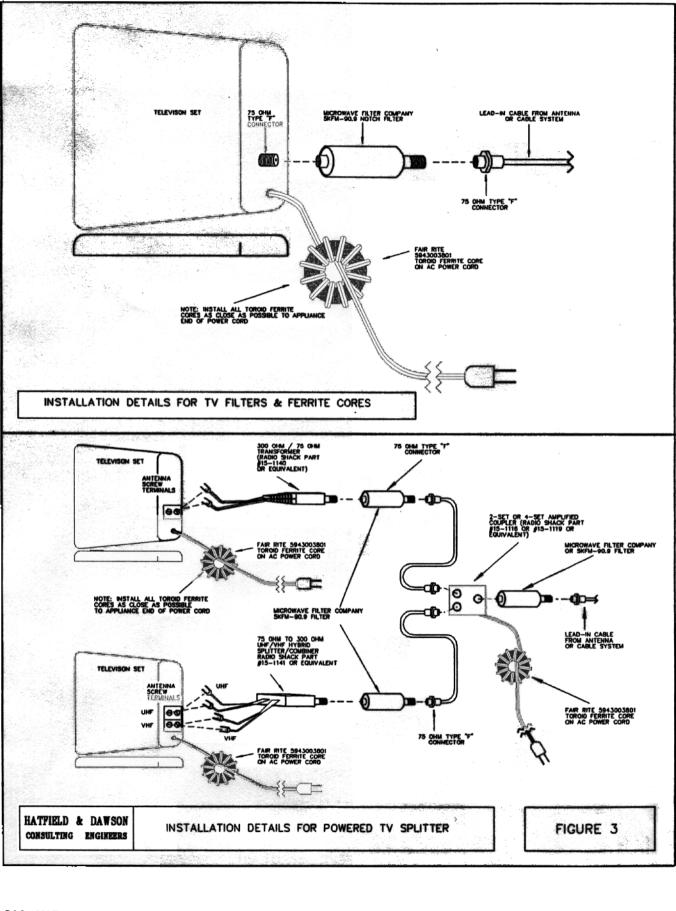
<u>Figure 3</u> shows the installation details for the filters and toroid cores. Drawings similar to those in <u>Figure 3</u>, along with detailed written instructions were provided to complainants as part of a "handbook" prepared by our firm, which describes how to resolve common blanketing interference problems.

! Home CATV Cabling - Many of the households we visited had extensive internal cable distribution systems, often using a single feed from the cable company and multiple splitters to feed as many as 10 TV receivers. This resulted in very low TV signal levels at the "downstream" end of these systems, which made the receivers connected to the cable much more susceptible to interference from the strong FM signal. In many cases, even replacing the cable in these systems with double-shielded coax did not reduce the level of the FM signal leaking into the system to eliminate the interference. In these cases, powered splitters were installed to increase the level of the desired TV signals at the downstream receivers. Notch filters were installed at the input of the powered splitter to prevent amplifier overload by the strong FM signal, as shown in Figure 3.

In nearly all cases, the installation of a Microwave Filter Company 5KFM-90.9 notch filter at the RF input connector of the TV and a Fair-Rite 04433164151 "clip-on" ferrite core or a Fair-Rite 5943003801 toroid core on the AC power cord eliminated the interference. (This technique was not effective for the channel 8 and channel 32 interference, since it was produced by a spurious signal on a frequency far outside the range of the notch filter, and because the use of a notch at the channel 8 or channel 32 frequencies would have eliminated the desired signals as well.) In some cases, the interference could not be eliminated using these techniques, and the TV had to be replaced with a new model known to be less susceptible to interference. Most of the TV's which had to be replaced were older models without an "F" connector integral to the tuner module. These TV's were usually overloaded by the FM radio frequency energy entering the tuner directly through the TV's case.

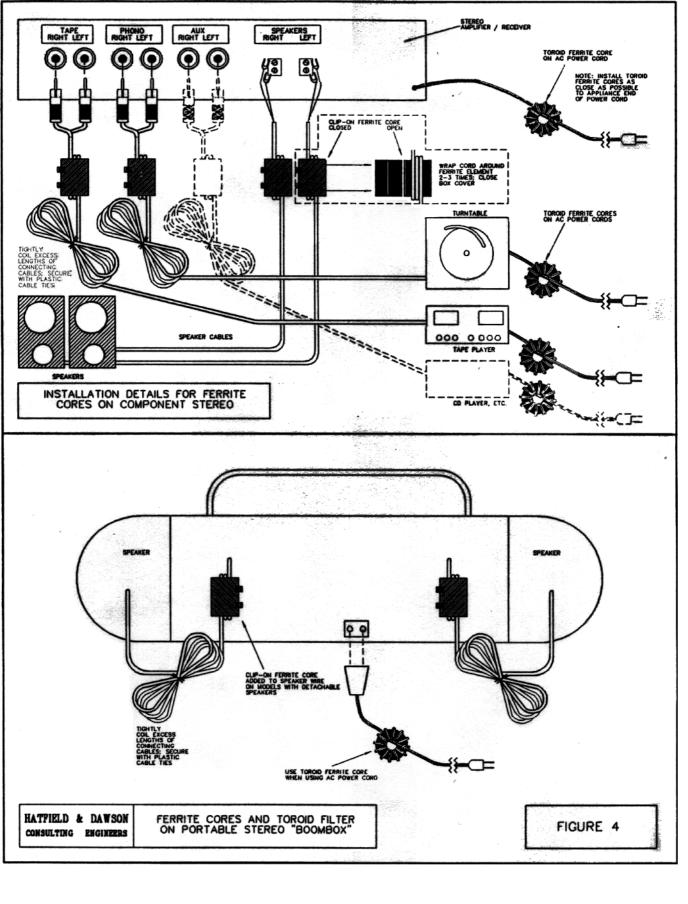
Boomboxes were an especially difficult problem, since many models have either a telescoping monopole external antenna or use the AC power cord as an antenna. Also, most boomboxes have plastic cases which provide little or no shielding against unwanted RF signals. In some cases, where the tuner section of the boombox functioned normally, but the tape player or the amplifier section suffered from RF rectification, it was possible to restore normal operation by installing ferrite cores on the speaker leads and the AC power cord, as shown in Figure 4.
